FRACTURE DETECTION AND ANALYSIS

PROCESSING AND PRESENTATION OF IMAGER RESULTS

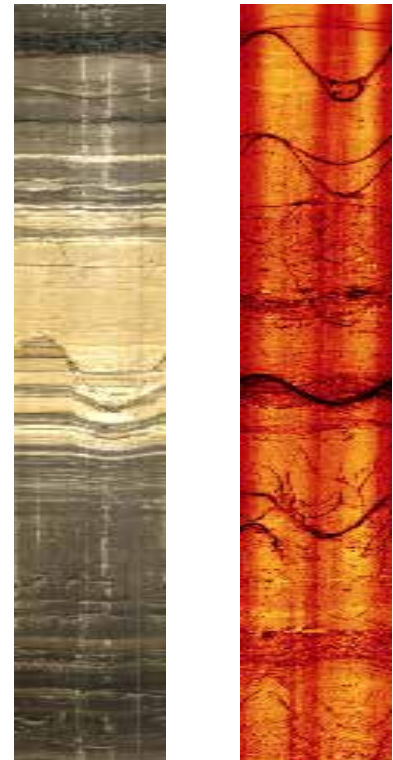
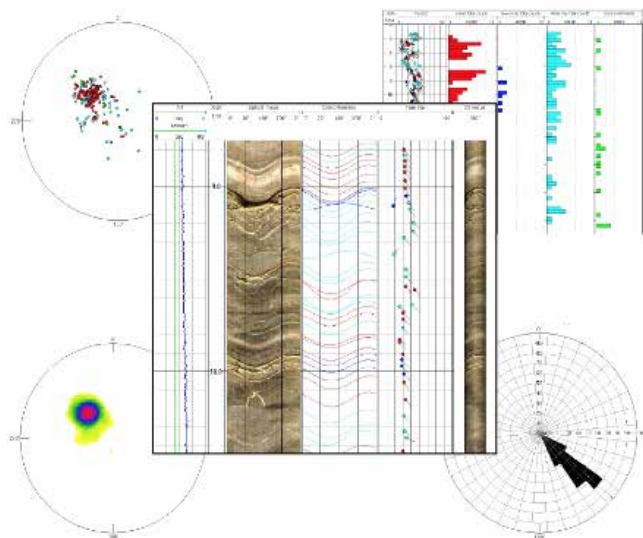
Detailed logs of the imager data can be produced at any vertical scale. The image of the borehole wall is presented in an unwrapped form with a horizontal scale marked 0°, 90°, 180°, 270° and back to 0°.

Structural features and discontinuities are picked from the images in the form of colour coded sinusoidal projections blue - fractures, red - bedding/fabric features, green -veins). This structural log is presented as 'Discontinuities' with a horizontal scale as the image data.

Using the borehole diameter, dip and azimuth along with the geometric parameters of the sinusoids the true azimuth and dip of the discontinuities are calculated and presented as a "tadpole" plot. The true dip data can then be used.
